CASE STUDY

# Footfall-induced office vibration problem

**Project:** Resolve excessive vibration caused by foot traffic

**Location:** Geneva, Switzerland

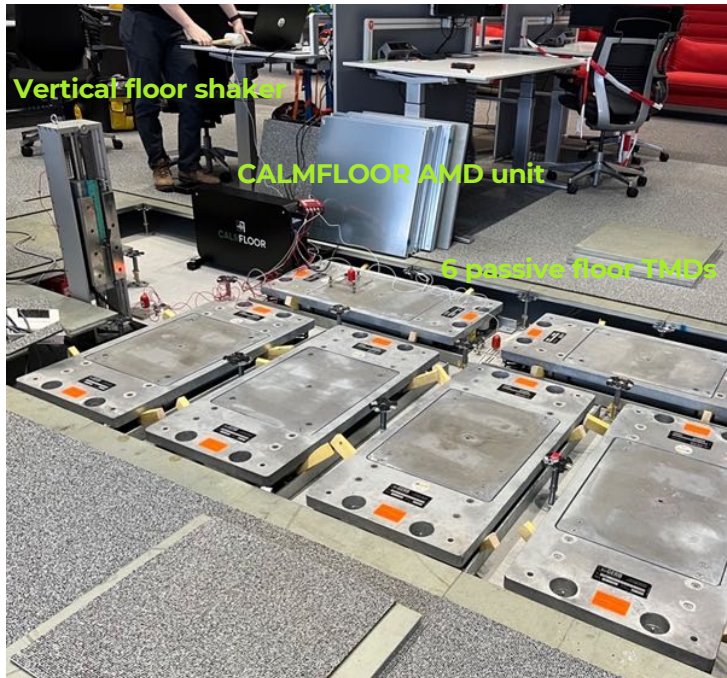
Figure 2: Six TMDs each with 250 kg moving mass and one 67 kg CALMFLOOR demo unit on top of the structural floor.

Initial mitigation employed six low-profile tuned mass dampers (TMDs), which achieved only limited improvement. CALMFLOOR was subsequently trialled on site, offering a practical and readily demonstrable alternative solution. This also provided, for the first time, an opportunity to carry out a direct in-situ comparison between the floor vibration reduction performance achieved by six TMDs operating in unison and a single CALMFLOOR active mass damper (AMD) (Figure 2).

The trial was supported by an independent vibration measurement consultant. Using their own accelerometers and a vertical shaker, also shown in Figure 2, the consultant measured the floor frequency response functions (FRFs) both with and without the TMDs and AMD operating. Measurement of FRFs is a widely used and effective method for comparing the performance of floor vibration control solutions.

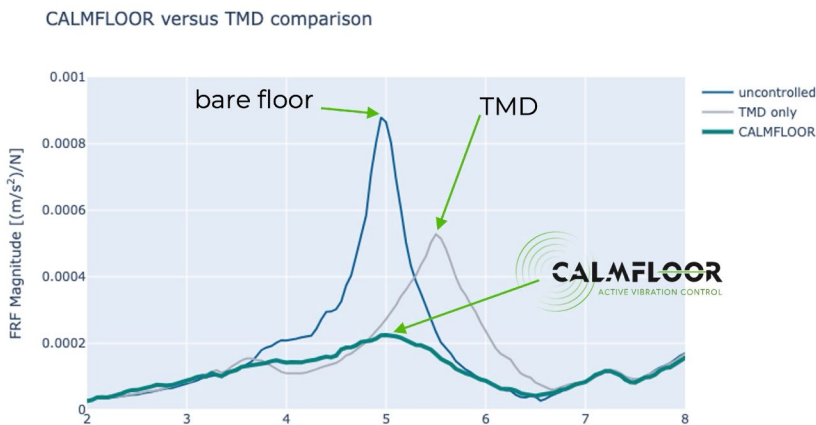
Figure 3: Point accelerance FRFs measured at the vertical shaker test location shown in Figure 2.

Figure 3 shows the so-called ‘point accelerance FRF’ corresponding to the vertical excitation and response measured at the same location as the vertical shaker in Figure 2.

The solid blue line shows the FRF modulus of the uncontrolled floor, with the masses of the six TMDs locked and not moving and the CALMFLOOR AMD switched off. This plot clearly shows a strong vertical vibration mode at around 5 Hz that required control, as previously mentioned.

The solid grey line shows the FRF modulus measured with the TMDs unlocked and their masses moving, while CALMFLOOR was switched off. This shows the TMDs reduced the vibration by producing classical mode splitting: one mode at about 3.8 Hz and one at about 5.6 Hz. However, this is not the neat symmetric split expected from a well-tuned passive mass damper. The two peaks are asymmetric, with the peak around 5.6 Hz significantly higher, resulting in a vibration reduction of the FRF peak of approximately 40%.

As a result, the significant moving mass of the six TMDs, totalling 1,500 kg, achieved only a 40% reduction of the FRF peak. The perceptible floor vibration was still easy to excite by normal walking. This was despite over 15 kN of static weight from the TMDs applied over a relatively small area of the floor. This concentrated weight presents a significant structural challenge: it reduces the floor's capacity to carry useful live loading for which it was originally designed.

The thick green line shows the FRF modulus with the TMDs locked and only the AMD operating. The shape of the FRF modulus shows that a single CALMFLOOR unit significantly increased damping and reduced the FRF peak by 75%. The 35 kg moving mass of the AMD outperformed the 1,500 kg TMD counterpart. A single CALMFLOOR unit was demonstrably able to control a broad range of frequencies between approx. 3.5 Hz and 6 Hz.

This is a common problem in lightweight floor structures in office buildings, where floor utilisation can change frequently. Such changes may include the location and type of non-structural partitions and furniture. These modifications can significantly alter the stiffness and mass distribution (i.e. the modal properties) of the floor used for the initial TMD tuning, leading to detuning and reduced performance of the previously installed TMDs.

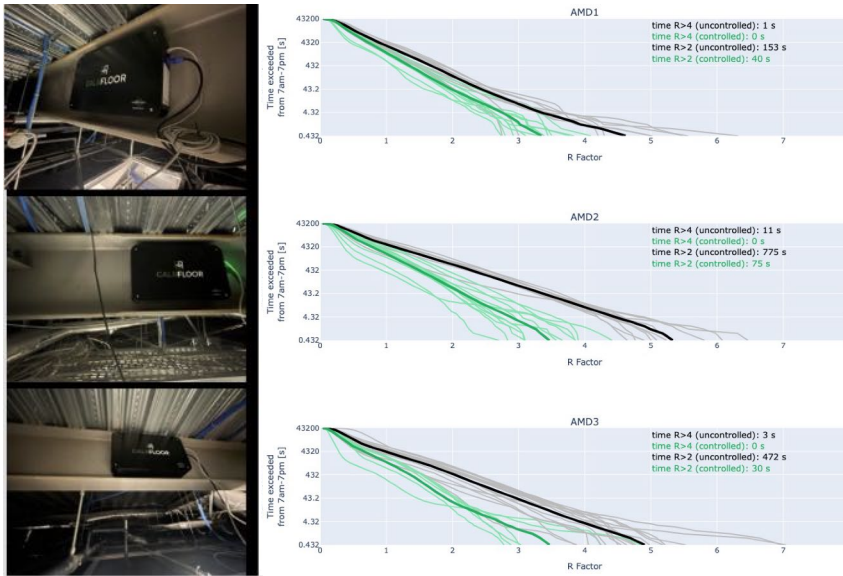
Figure 4: Left – CALMFLOOR units installed on secondary beams at mid-points of three floor bays (~500 m<sup>2</sup>). Right – the number of seconds during which 1 s RMS vertical floor acceleration was above the response (R) factor given on the horizontal axis with CALMFLOOR off and on.

Figure 4 (left) shows the three installed CALMFLOOR units. All units were installed in just 4 hours by two technicians using a mobile elevated platform. The installers had not previously worked with CALMFLOOR units and simply followed the published installation guidance.

The data were plotted in Figure 4 (right) – one for each of the installed CALMFLOOR units shown. The vertical axis shows the number of seconds the floor vibration is greater than the R factor shown on the horizontal axis.

The thick black line shows the average performance when CALMFLOOR was switched off, and the thick green line shows the average when CALMFLOOR was running.

Floor vibrations above  $R = 2$  are considered perceptible. CALMFLOOR significantly reduced the duration when floor vibrations were higher.

For example, at the location of middle unit (AMD2), the duration of  $R > 2$  was reduced from 775 s per 12h to only 75 s, perceived by users as a considerable improvement.

Regardless of the criterion considered, CALMFLOOR considerably reduced the duration of exceedance across all R factors. The office criterion  $R > 4$  was never reached at all three locations when CALMFLOOR was operating.

Having established the potential for excellent in-situ performance of CALMFLOOR, a total of three units were installed and commissioned. One unit per floor bay were used, with three units controlling a total area of approximately 500 m<sup>2</sup>. The three CALMFLOOR units were attached to the webs of the secondary I-beams located close to the centre of each bay (Figure 1).
